Re: 2019 Bridge Rehabilitation Projects

3.0 Corn Valley Road Bridge

3.1 Bridge Observations

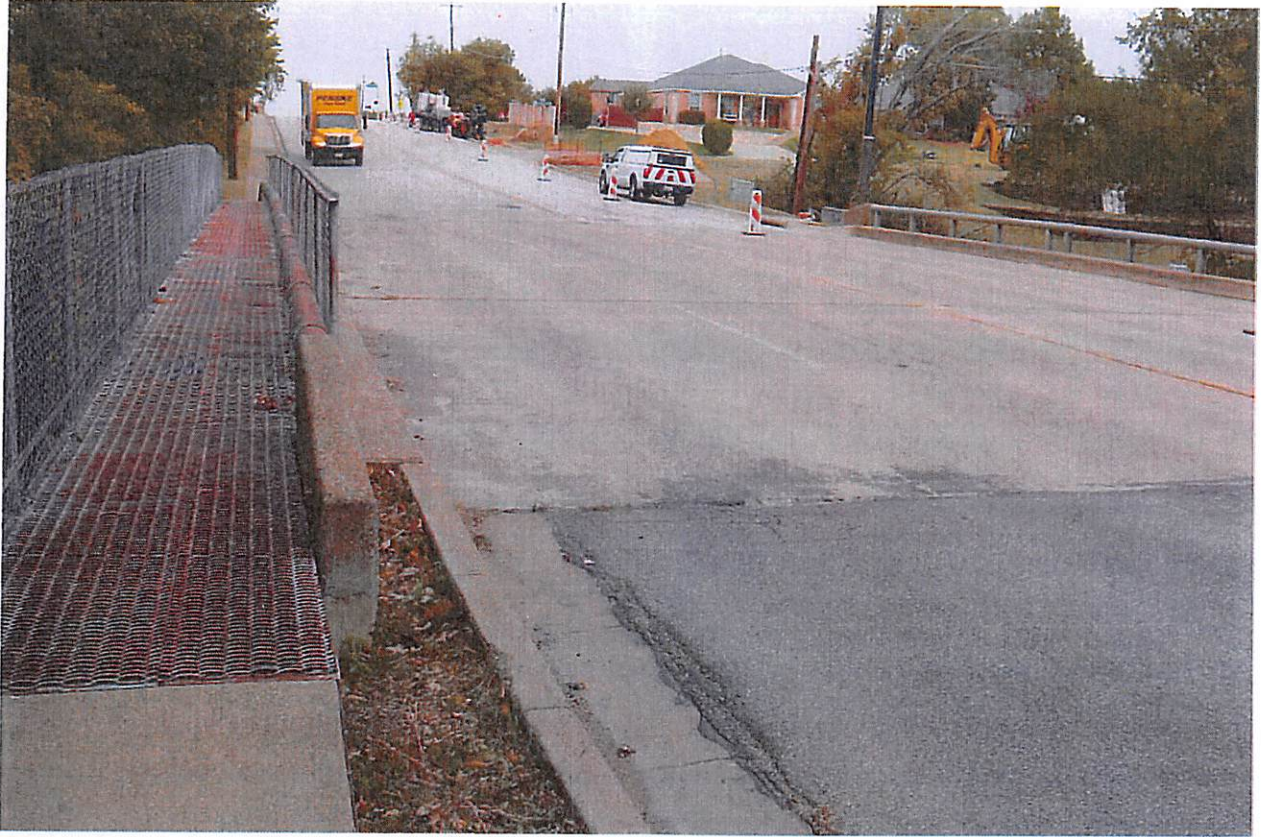
Rail: The steel bridge guard rails do not meet current standards. No MBGF transitions, rail, or end treatments are present. A pedestrian walkway is presently attached to the western side of the bridge and constructed of steel framing with expanded metal mesh walking surface and chain link fence handrail. This

Figure 17: Bridge Deck and Walkway (Looking North)

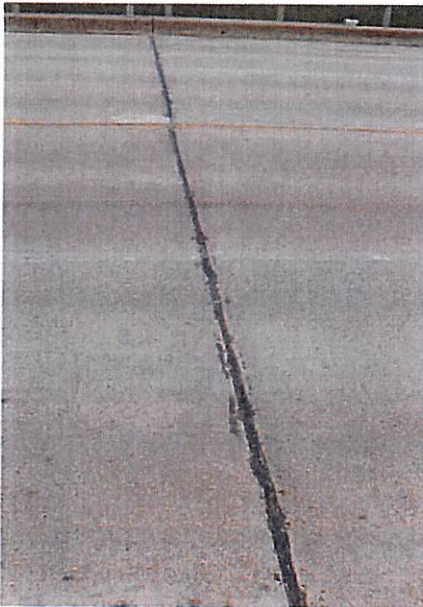
Figure 18: Expansion Material Deteriorating

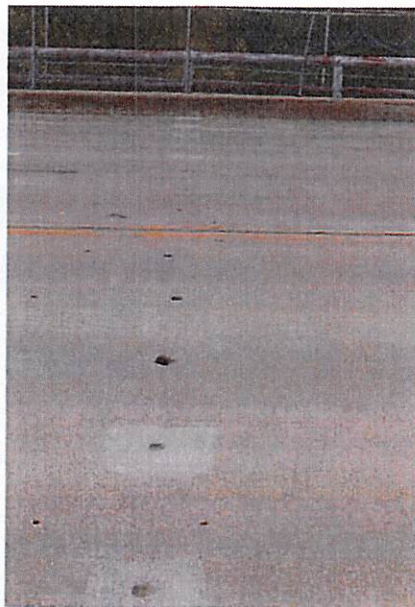
Deck: The concrete deck is in satisfactory condition and only shows minor hairline cracking consistent with a bridge of this type and age. Several of the form holes located at the midpoint of each span and of each arch between girders are clogged or have minor cracking allowing water to infiltrate the deck instead of passing through the holes. Expansion joints over girder supports are deteriorating and allowing dirt and debris to accumulate in the joints. The approach slabs are failing. The northwest approach slab in particular has completely buckled and multiple layers of HMA patch are present.

Figure 19: Form Holes are Inadequately Maintained

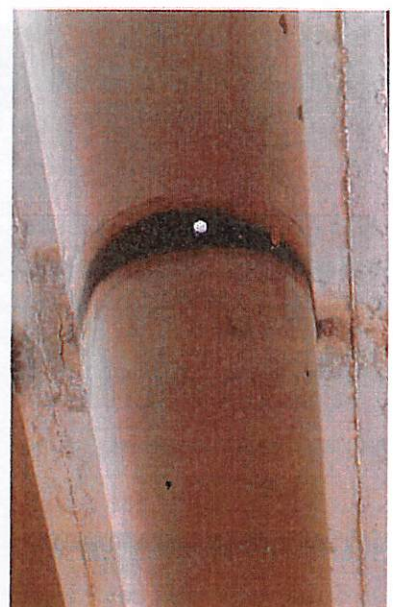
Figure 20: Underside of Arch - Water has begun to Infiltrate the Concrete

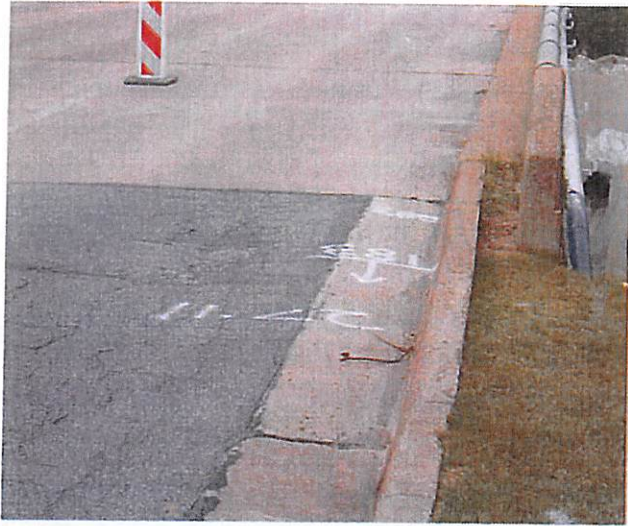
Figure 21: No MBGF and Failing Pavement at Northbound Lanes

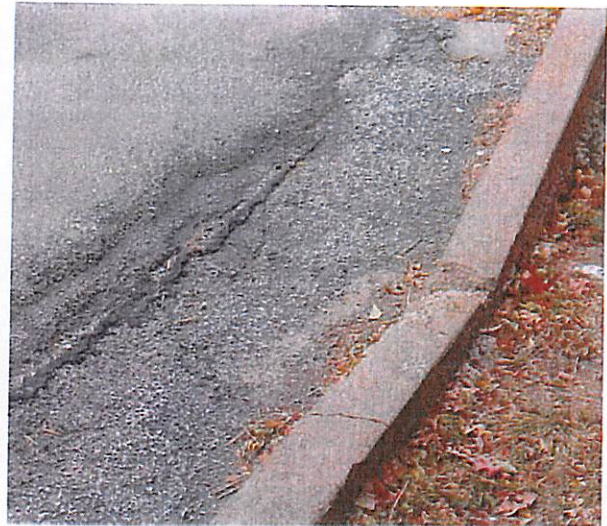
Figure 22: Broken Approach Slab at Southbound Lanes

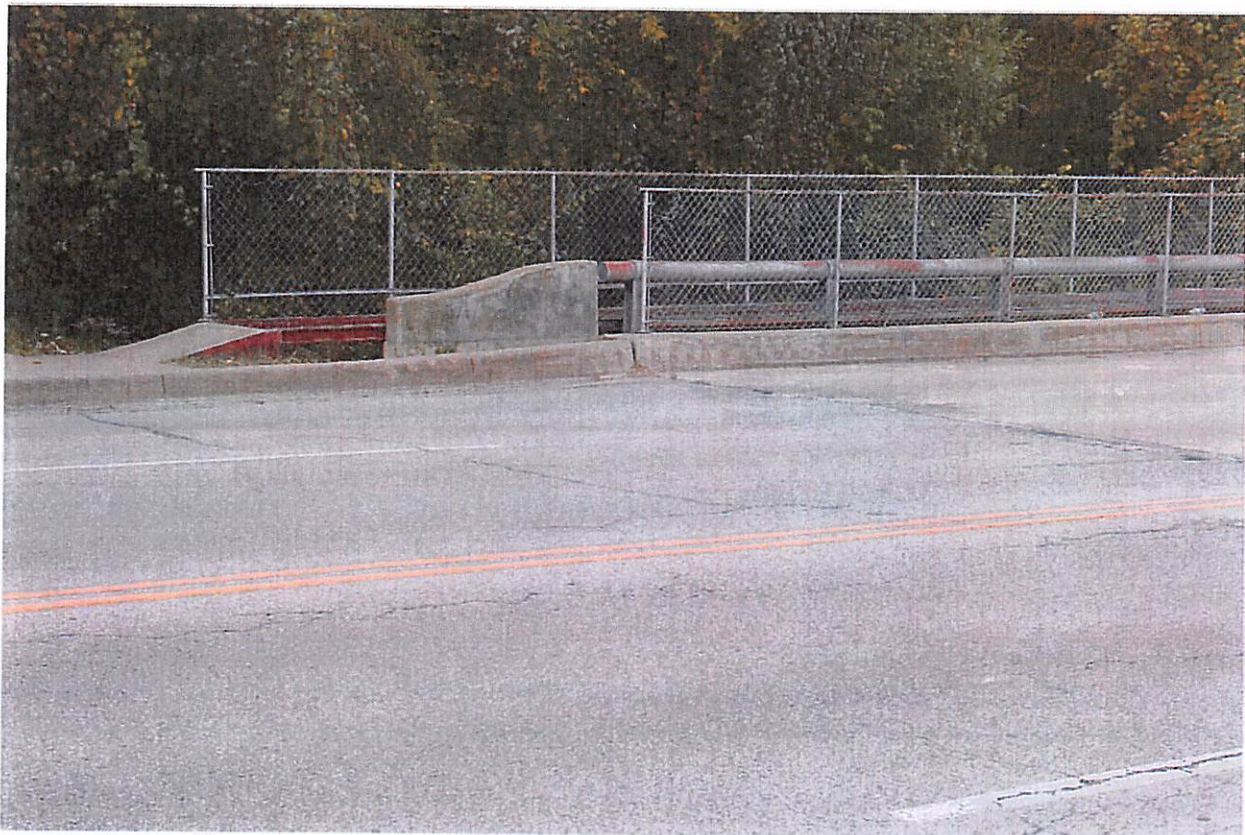
component appears to be in adequate condition but is not ADA accessible. The mesh walkway and the steep approaches at both ends limit accessibility.

Figure 23: Pedestrian Walkway is Not ADA Compliant

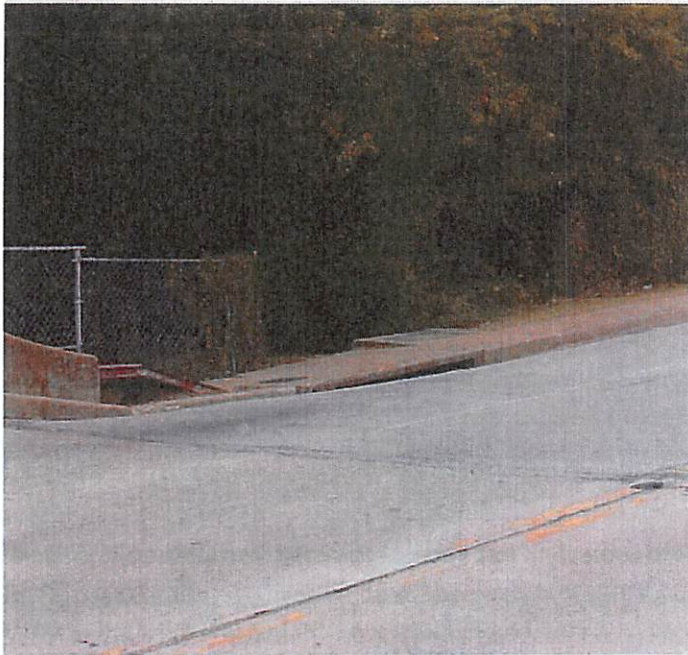
Substructure: The concrete substructure overall is in fair condition with several areas of concern. At the northwest corner, erosion has undermined the abutment cap and backwall causing the wingwall to separate from the backwall. This erosion and separation has also caused the approach slab to fail and buckle. Adjacent to the approach slab, a concrete curb inlet has also suffered vertical translation due the erosion causing loss of support. A steel ramp has been added to access the pedestrian walkway but remains out of compliance with ADA standards. Additionally, concrete is spalling and reinforcement is exposed at several locations along the interior bent caps and the abutment caps.

Figure 24: Failed Approach Slab and Curb Inlet due to Loss of Support

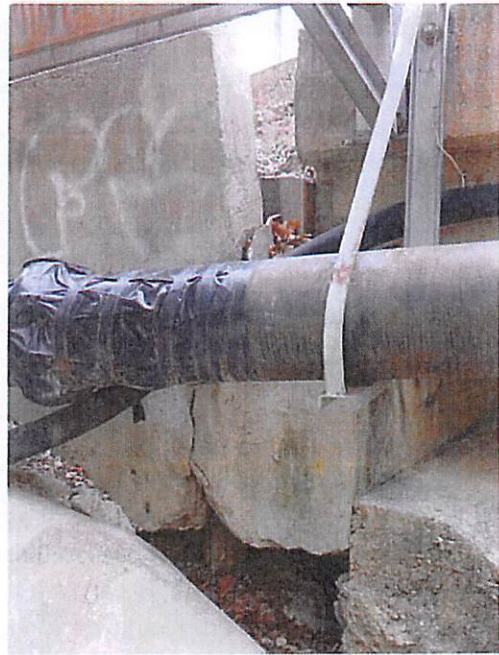
Figure 25: Separation of Wingwall from Abutment Backwall due to Undermining

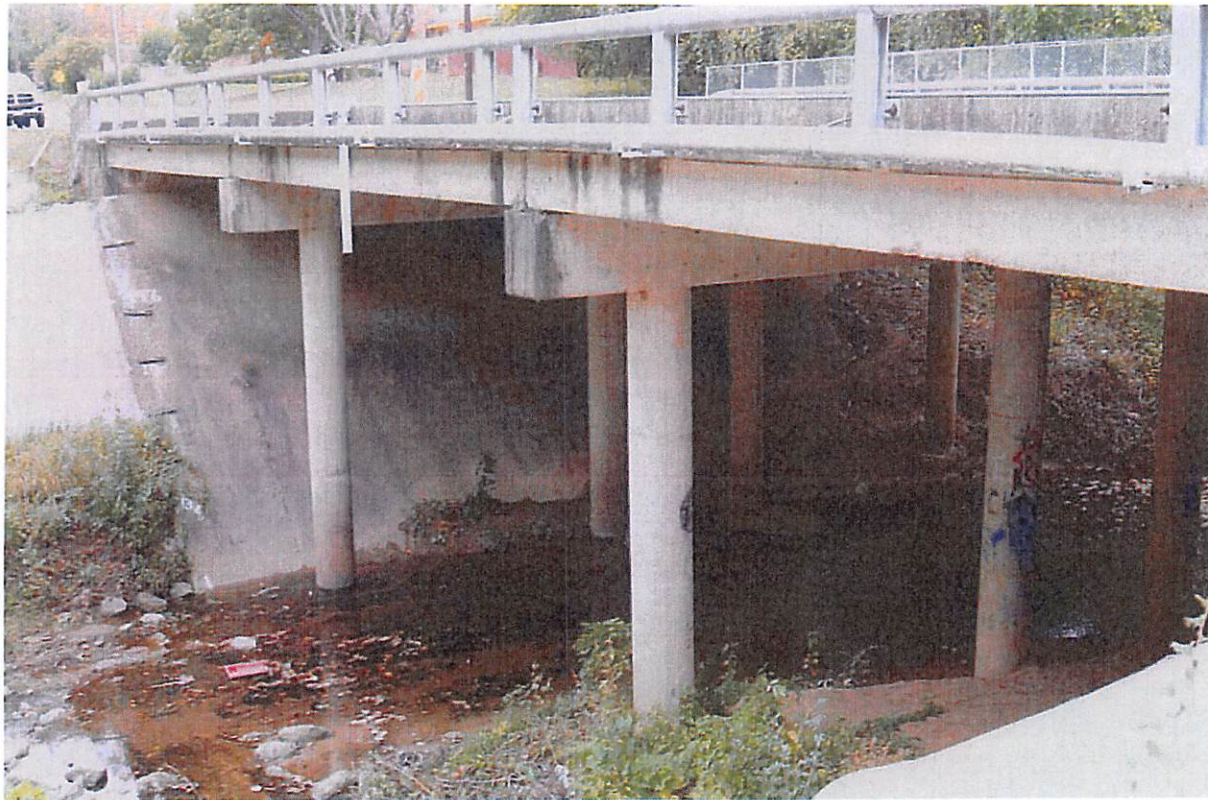
Figure 26: Concrete Columns and Bents in Satisfactory Condition

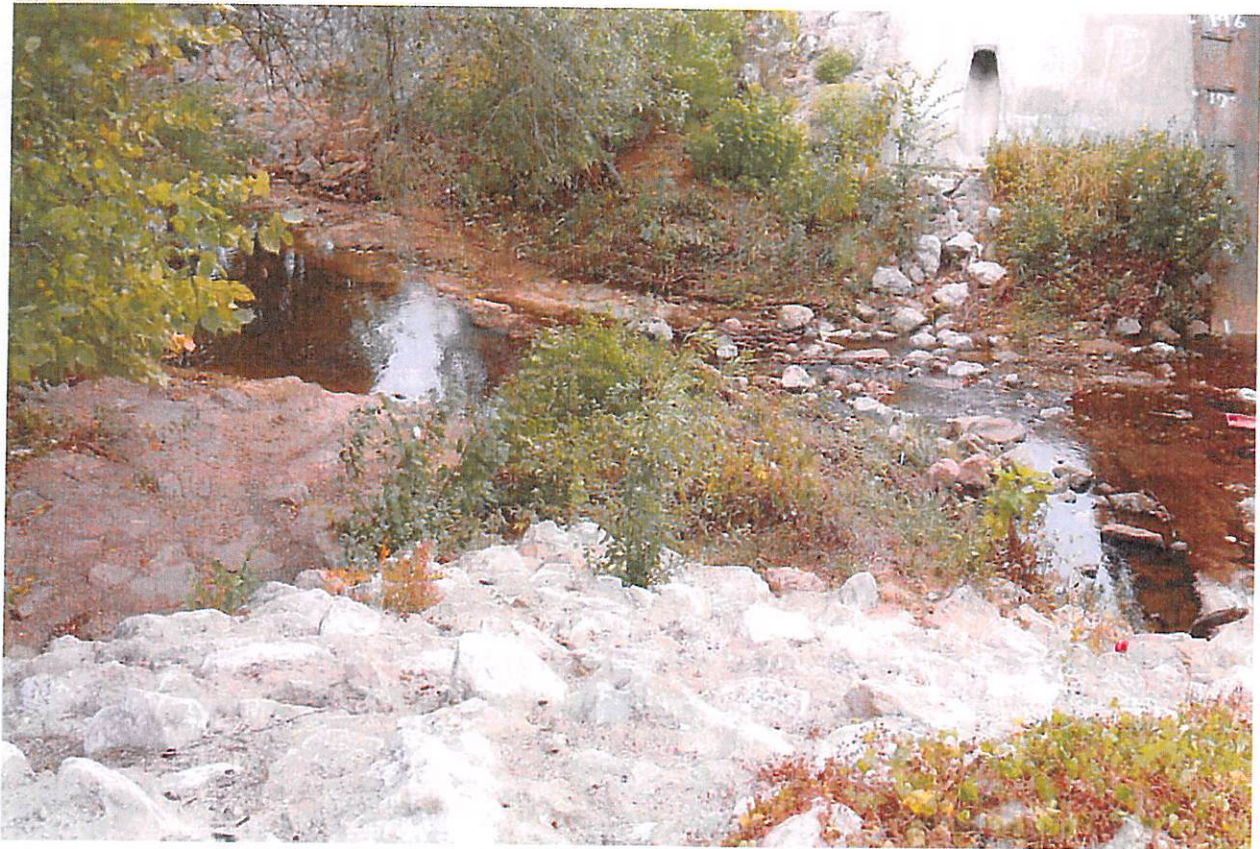
Figure 27: Grouted Rock Riprap at East Side of Bridge

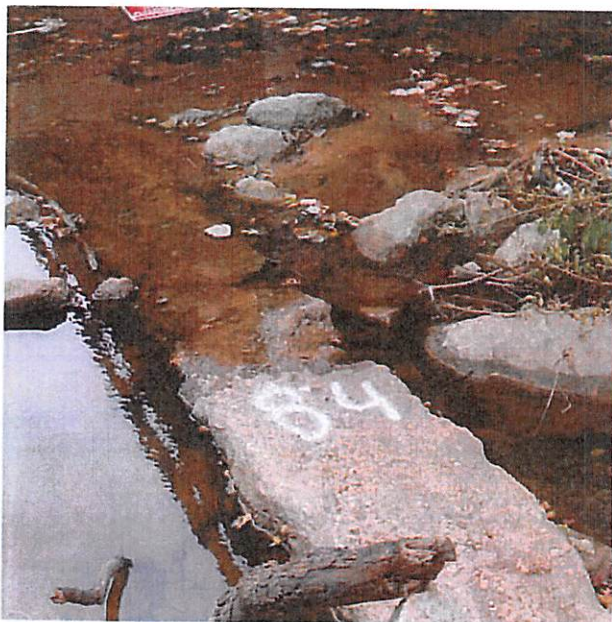
Figure 28: Exposed Concrete Encasement

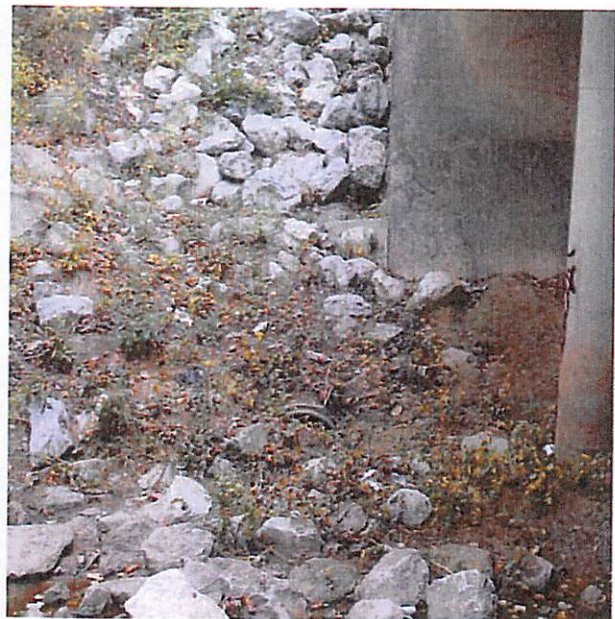
Channel & Approaches: Attempts to stabilize both sides of the channel are apparent and is in good condition. The erosion at the northwest side of the abutment is not being controlled by the existing measures. Areas of loose stone have washed into the channel and are collecting debris. Erosion at the channel bottom has exposed concrete encasement or duct bank. The RCP storm outfall for the curb inlet near the northwest approach slab is almost buried to the the pipe's crown.

Figure 29: Buried RCP Pipe and Loose Rock Riprap
