Exhibit A Scope of Services

Re: 2019 Bridge Rehabilitation Projects

4.0 South Carrier Parkway Bridge

5.0 Mirabella Boulevard Bridge

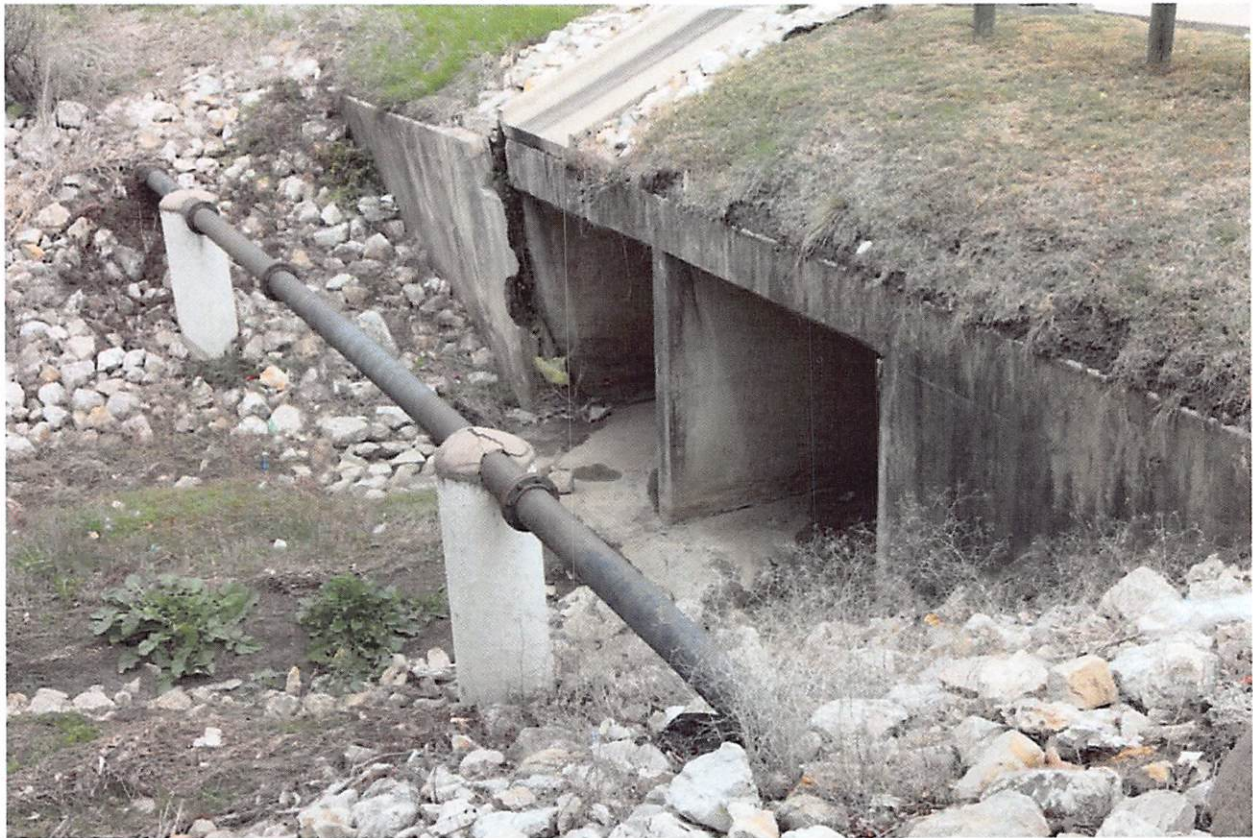
Culverts: The concrete box culverts are in good condition. The base and walls exhibit very minor cracking and slight spalling throughout. Areas of exposed reinforcement are present due to lack of cover during construction. The northwest wingwall has broken and separated from the structure and will continue to translate away from the roadway. The southwest wingwall is beginning to crack. The southeast wingwall has cracked and is beginning to separate away from the top slab. The northeast wingwall is also cracking. Additionally, a cedar tree is growing on the fill slope directly adjacent to this wingwall.

Figure 31: Western Headwall Showing Failed Wingwall

- Roadway: No recommendations other than patching at existing inlet.
- Rail: Install new MBGF posts and reset terminals.
- Culverts: Remove loose and spalled concrete and rub/fill those areas with polymer-modified concrete. Replace northwest wingwall in its entirety; repair the other three wingwall corner connections.
- Channel: Replace rock riprap disturbed during construction of new wingwalls.
- Miscellaneous: Remove existing cedar tree; Repair and re-set inlet.

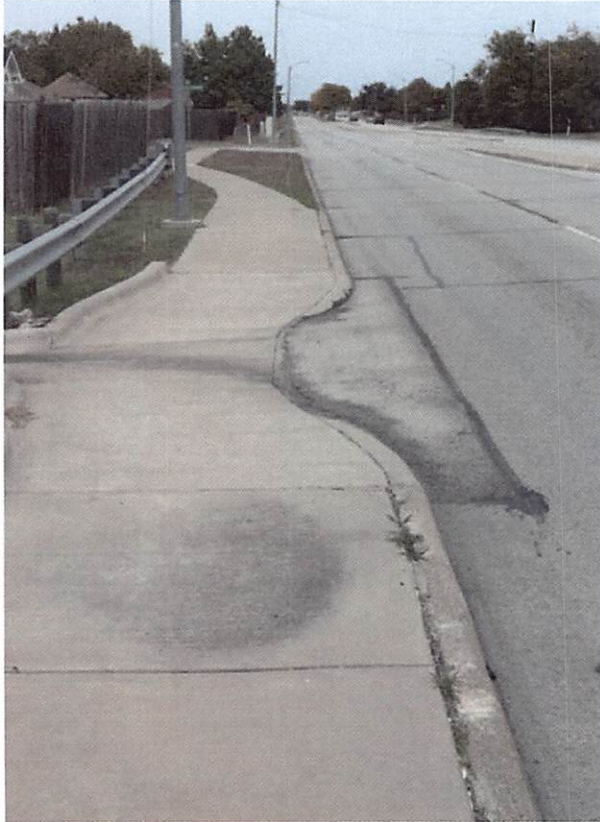
Miscellaneous: A portion of the adjacent parking lot at the southwest side has recently been reconstructed and now directs water through a small flume onto the upper bank of the channel. Erosion is occurring under the sidewalk at this area where small diameter gravel has been placed and is washing away. Two existing aerial utility crossings (one on each side of the roadway) are in good condition.

Figure 32: Drainage Flume (Looking North)

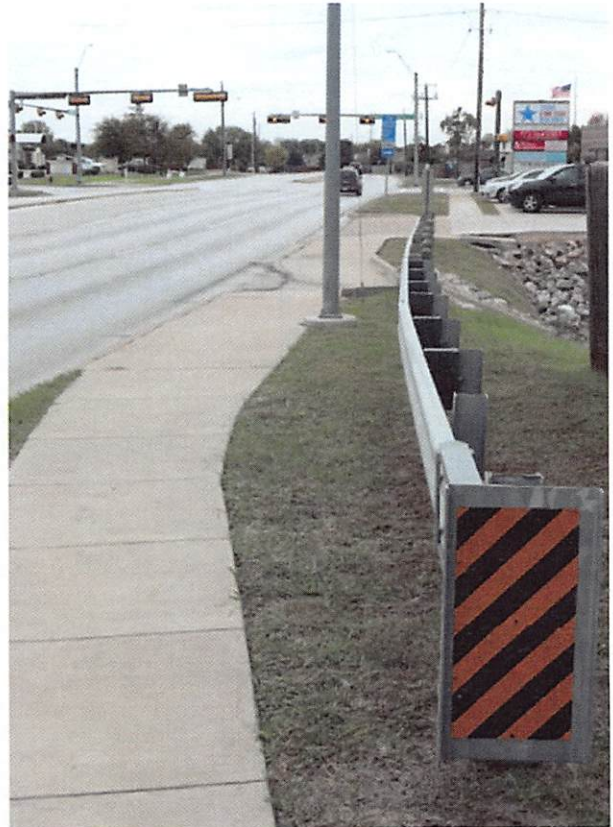
Figure 33: SGT for Southbound Traffic

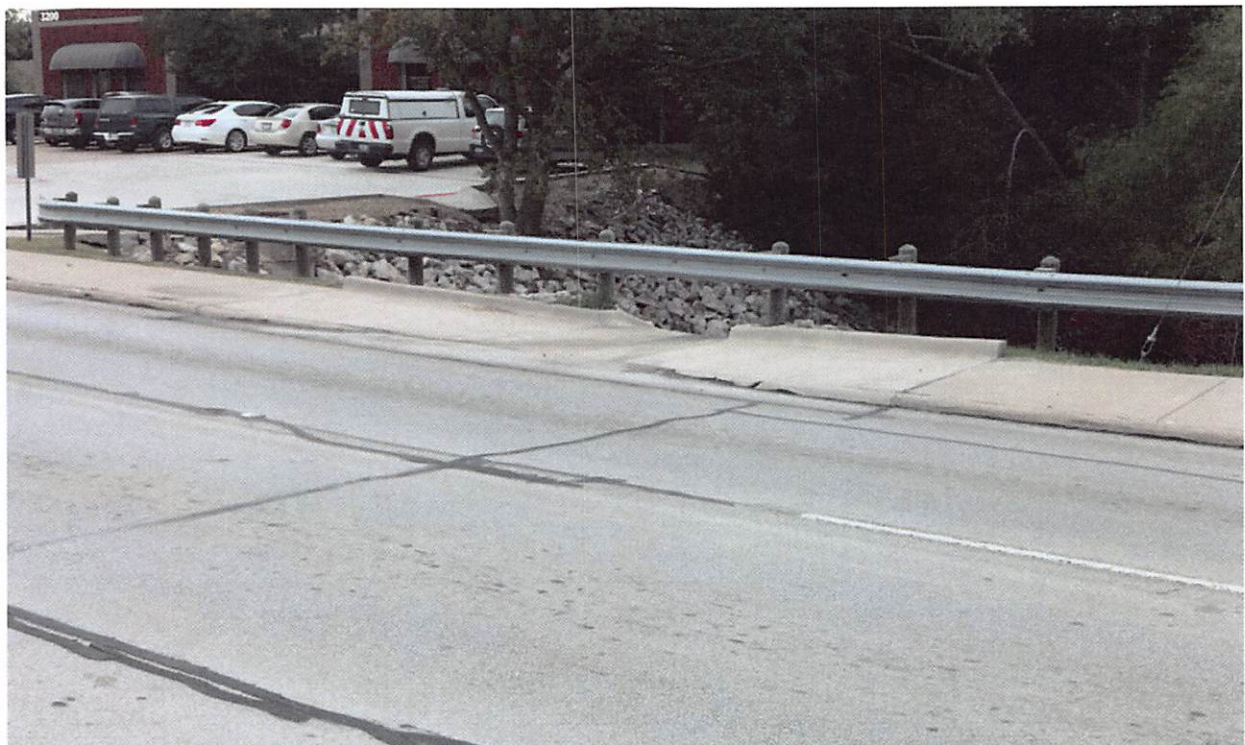
Figure 34: Drainage Flume, MBGF, and Channel Riprap (Looking West)

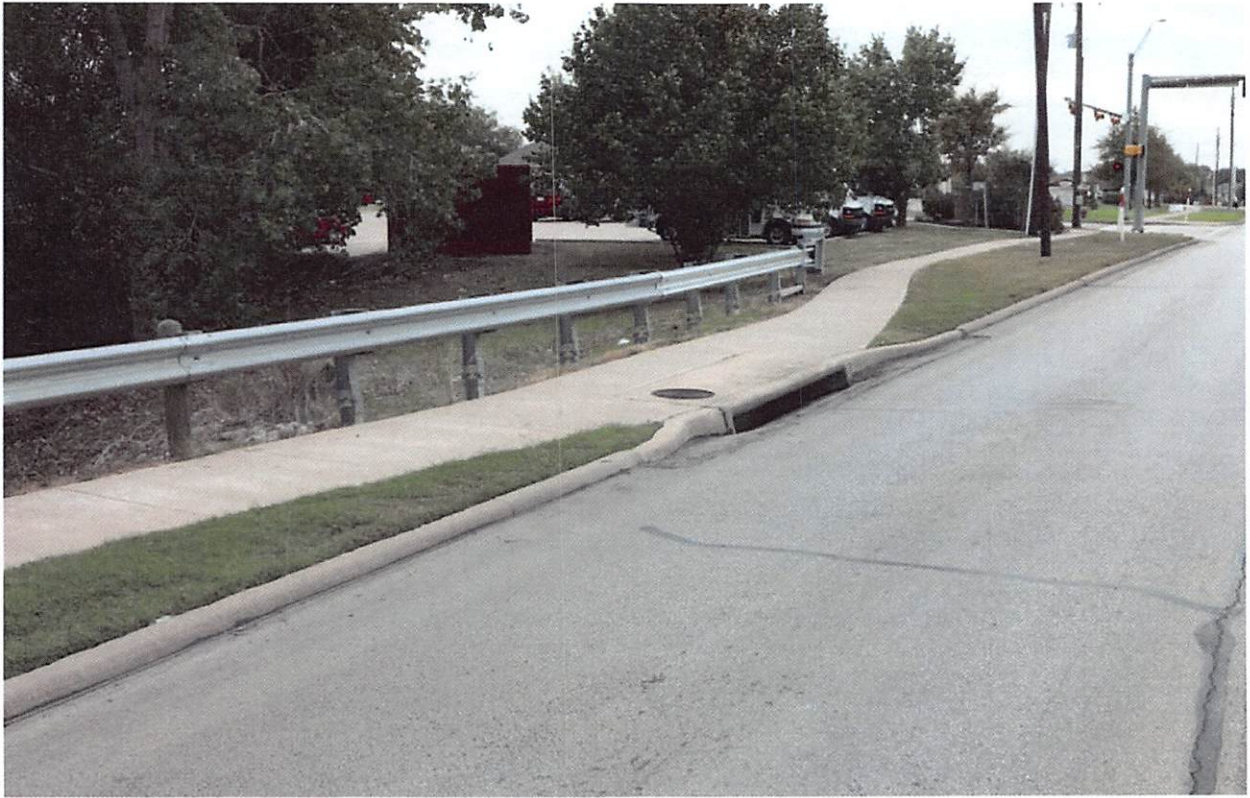
Deck: The HMAC roadway is in good shape at this crossing. Cracks have been maintained and sealed. The curb inlet on the east side of the roadway sitting above the multiple box culvert has settled and separated from the roadway. This vertical separation is almost three inches. Water is also overtopping the inlet and causing erosion under the adjacent sidewalk and down the fill slope. It appears that the western drainage flume may have been added as a replacement for a previous curb inlet. The flume and sidewalk are in good condition.

Figure 35: Curb Inlet on East Side (Looking South)

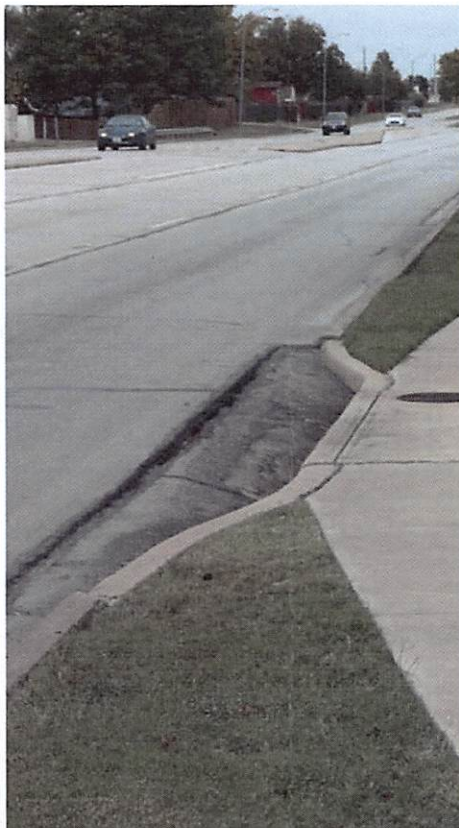
Figure 36: Curb Inlet has Moved

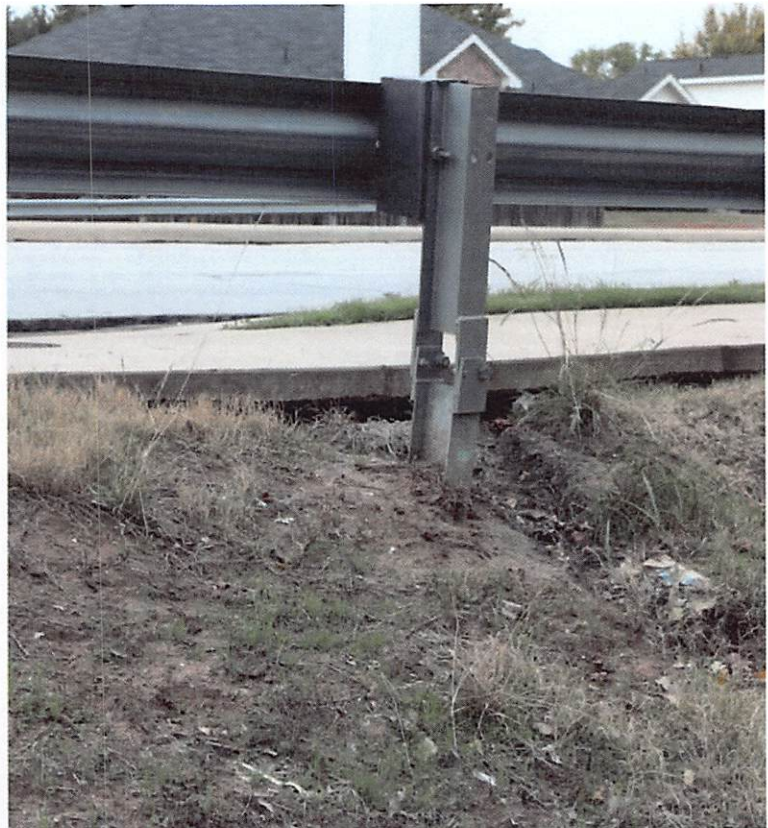
Figure 37: Erosion Behind Inlet Under Sidewalk

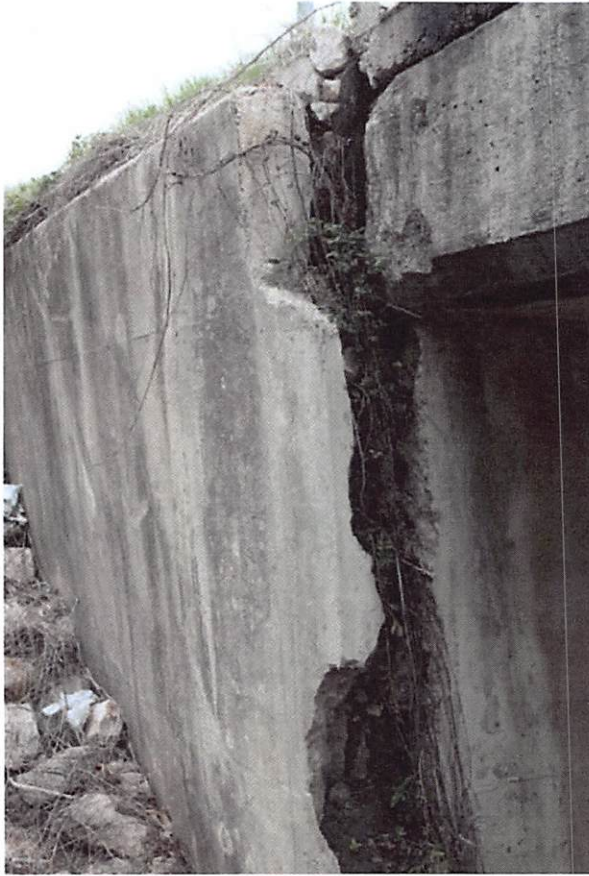
Figure 38: Northwest Wingwall

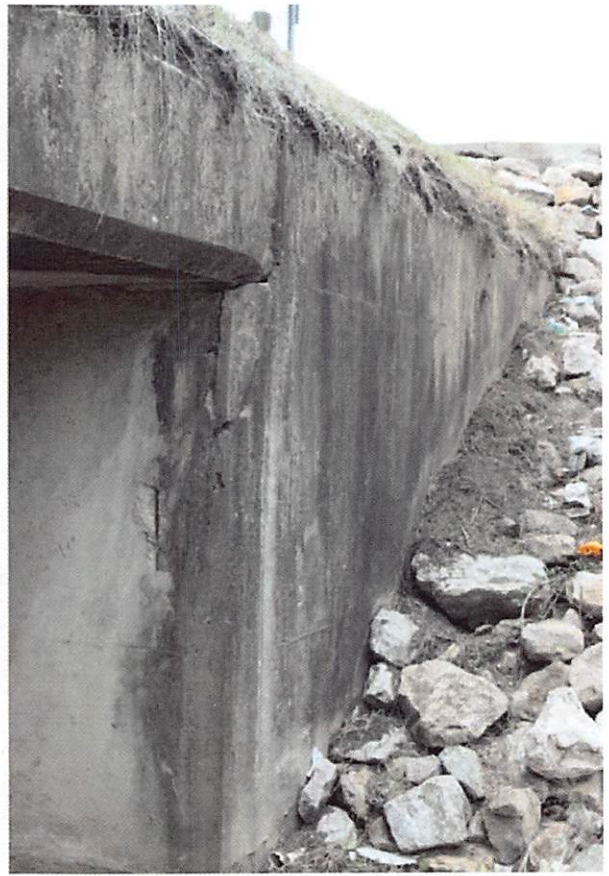
Figure 39: Southwest Wingwall

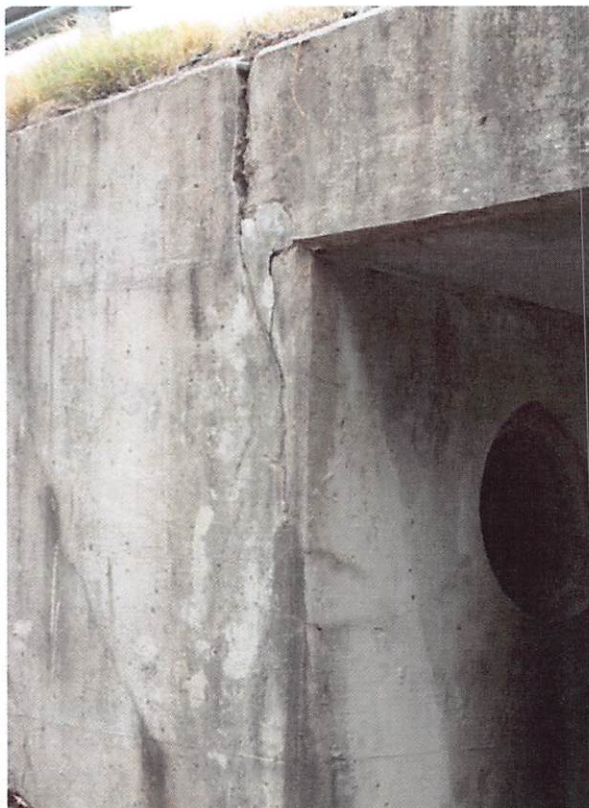
Figure 40: Southeast Wingwall

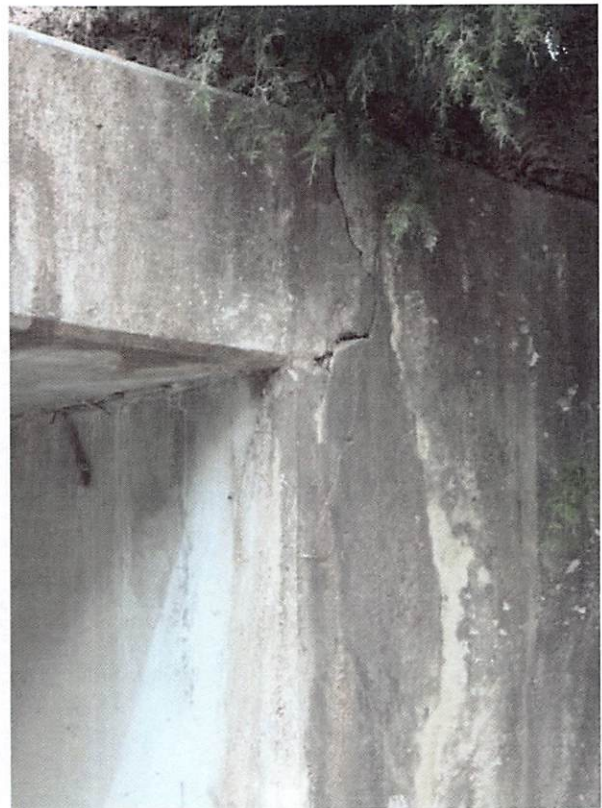
Figure 41: Northeast Wingwall

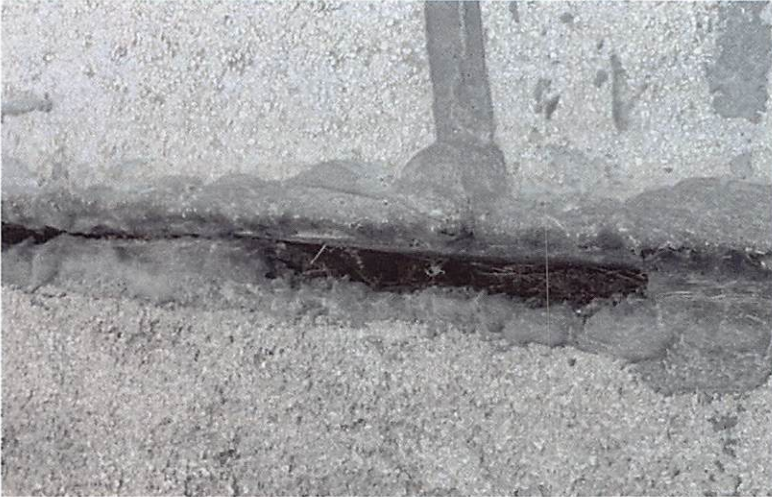
Figure 42: Separation at Inlet

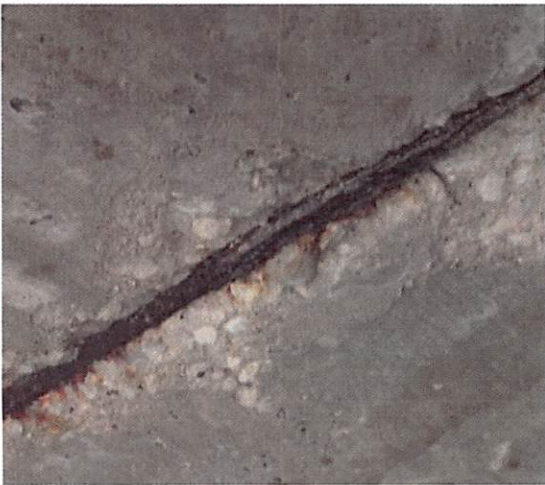
Figure 43: Exposed and Corroded Reinforcement

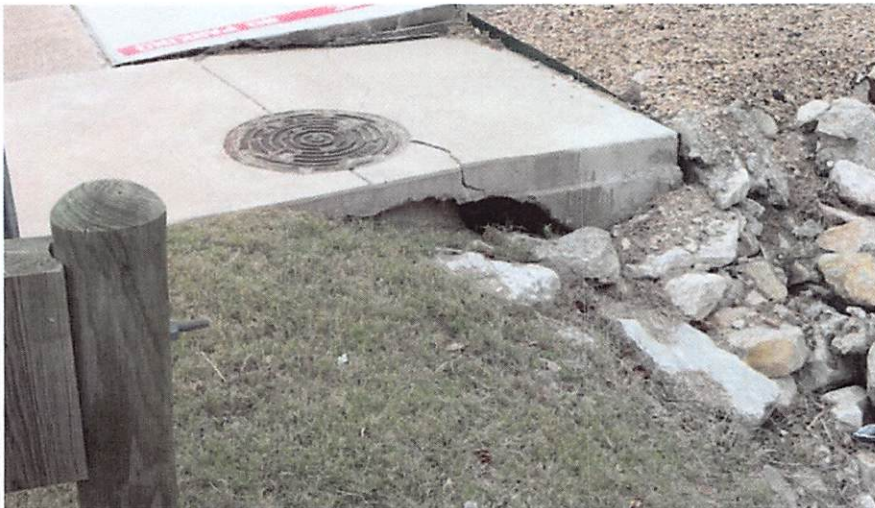
Figure 44: Erosion under Sidewalk Near Adjacent Parking Lot

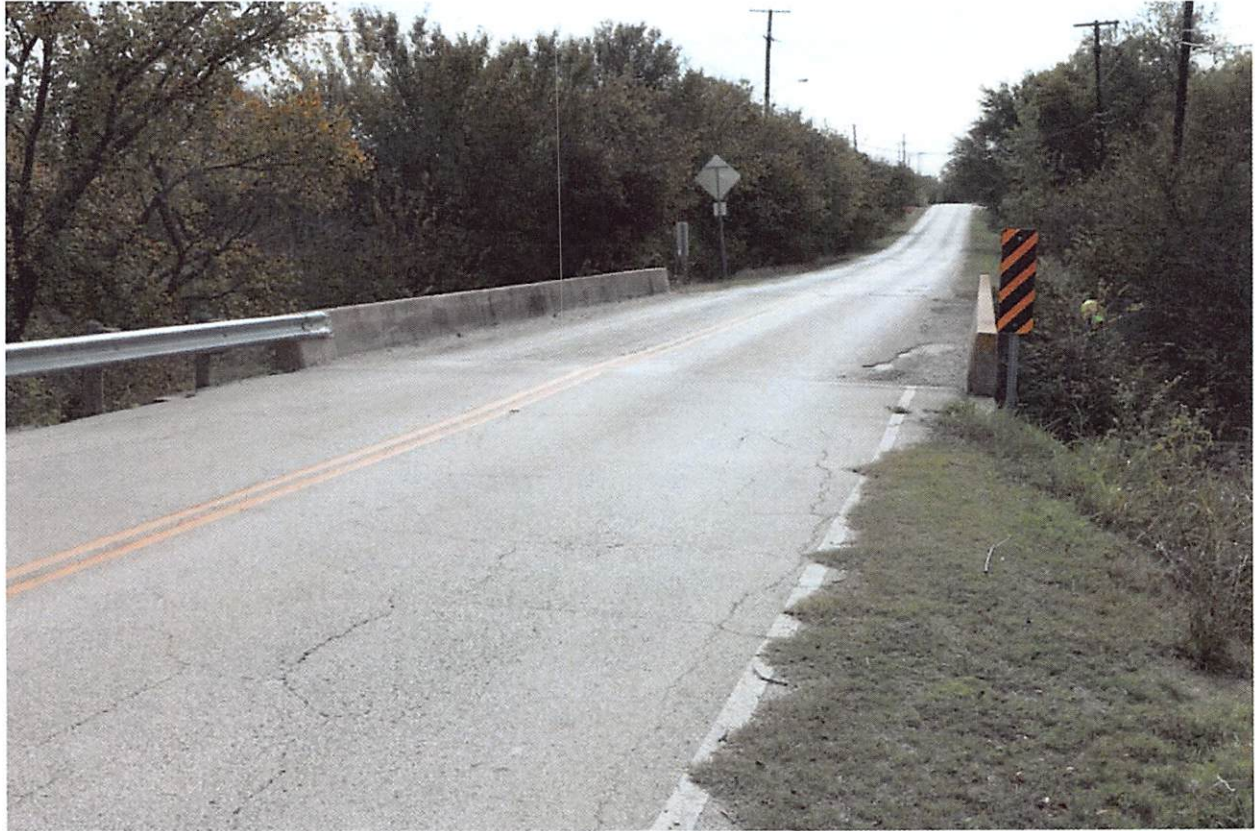
Rail: The concrete bridge parapet rail is in good condition with no visible impact damage or repairs. Some visible spalling is noticeable but no reinforcement is exposed. Only one section of MBGF has been attached to the concrete parapet at the northeast corner. The other three corners of the bridge remain exposed and unprotected.

Figure 46: Only One Section of MBGF - Looking South

- Roadway: Mill existing asphalt at both sides of bridge and repave
- Approaches: Approach slabs shall be removed and replaced
- Bridge Deck: Mill existing asphalt and repave
- Rail: Install new steel guard rail including MBGF transitions and terminals at all bridge corners.
- Substructure: Remove any loose and spalled concrete and rub/fill those areas with polymer-modified concrete.
- Abutments: Install weep holes into original bridge abutment walls. Construct new wingwalls to stop erosion.
- Channel: Provide additional stabilization measures as necessary (grouted rip-rap)
- Miscellaneous: Geotechnical borings at this location are recommended to determine the makeup of the rock layers adjacent to the channel.

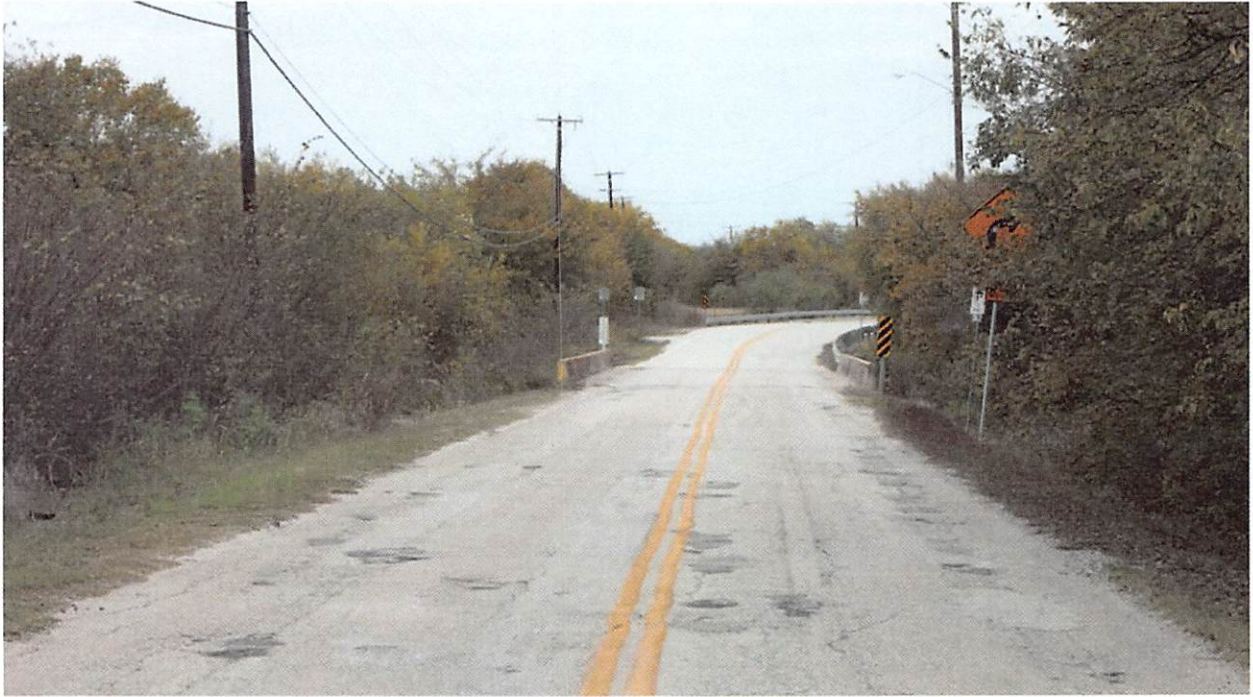
Deck: Overall, the deck is in good condition with only minor hairline cracks visible on the deck underside. The HMAC wearing surface is worn through in several areas. It is apparent that several attempts have been made at patching the roadway over the approach slabs.

Figure 47: Road Surface with Many Potholes - Looking North

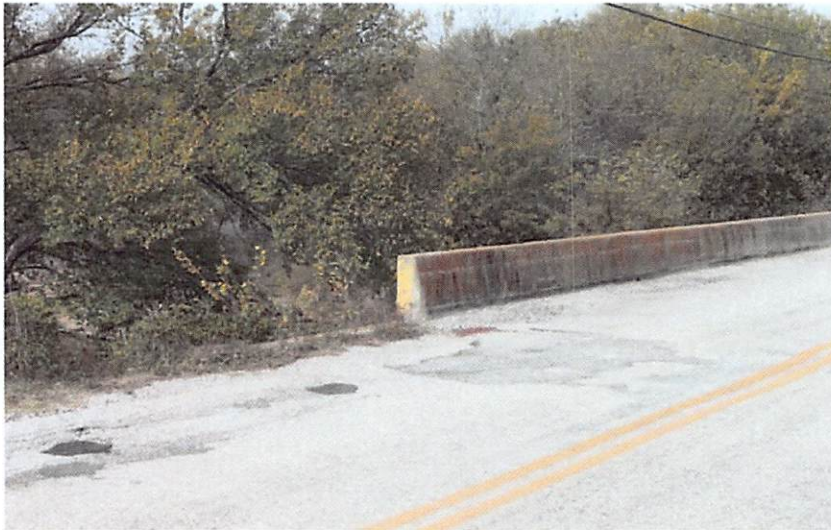
Figure 48: Failed Pavement has been Patched Multiple Times

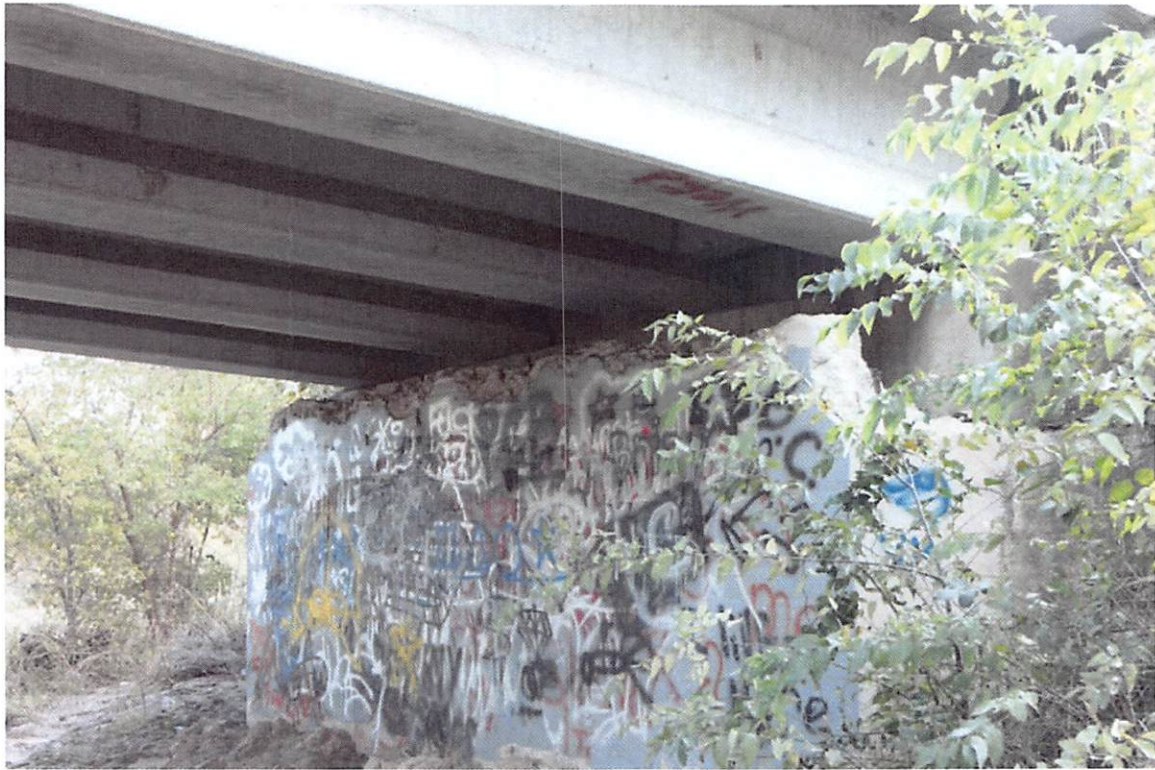
Substructure: The original concrete bridge abutments from a previous bridge are still present and being used essentially as retaining walls for the current bridge abutments. The current pier cap and abutment have been constructed immediately adjacent to the old abutment. Erosion near the sides of the old abutment is extending up the slope and beginning to undermine the approach slabs.

Figure 49: Original Abutment from Earlier Bridge is Still Present (South Side)

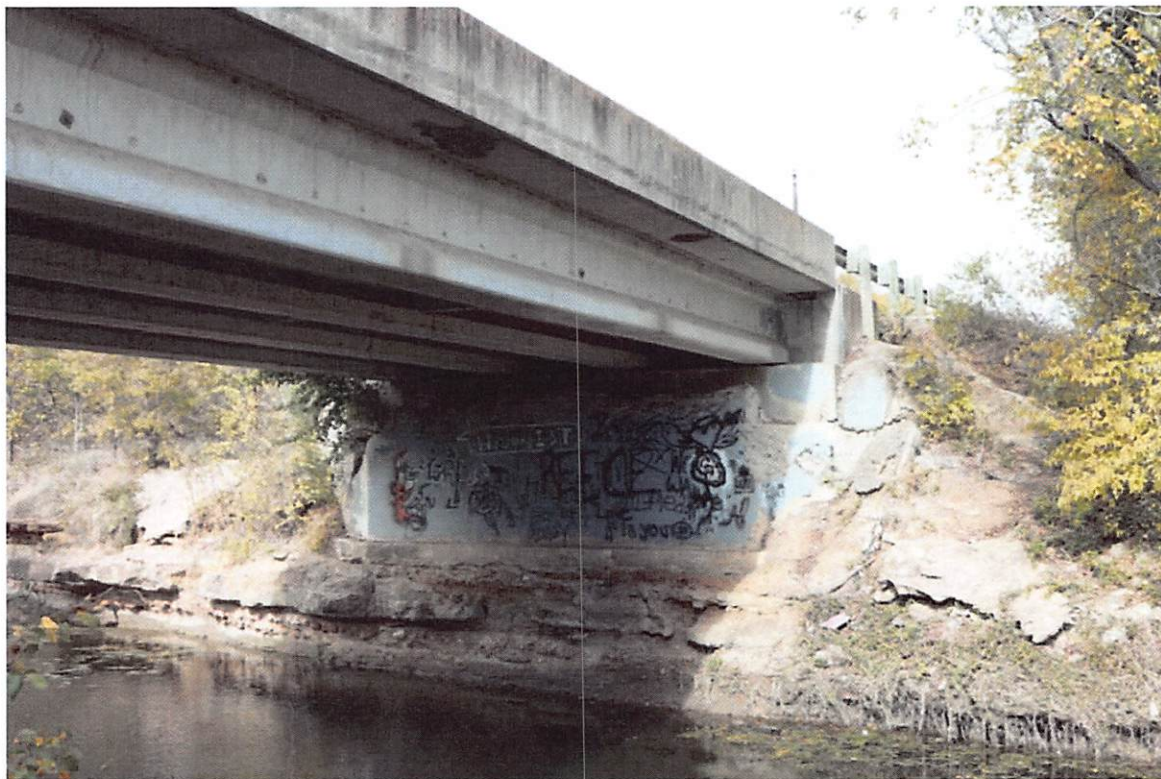
Figure 50: North Side Abutment

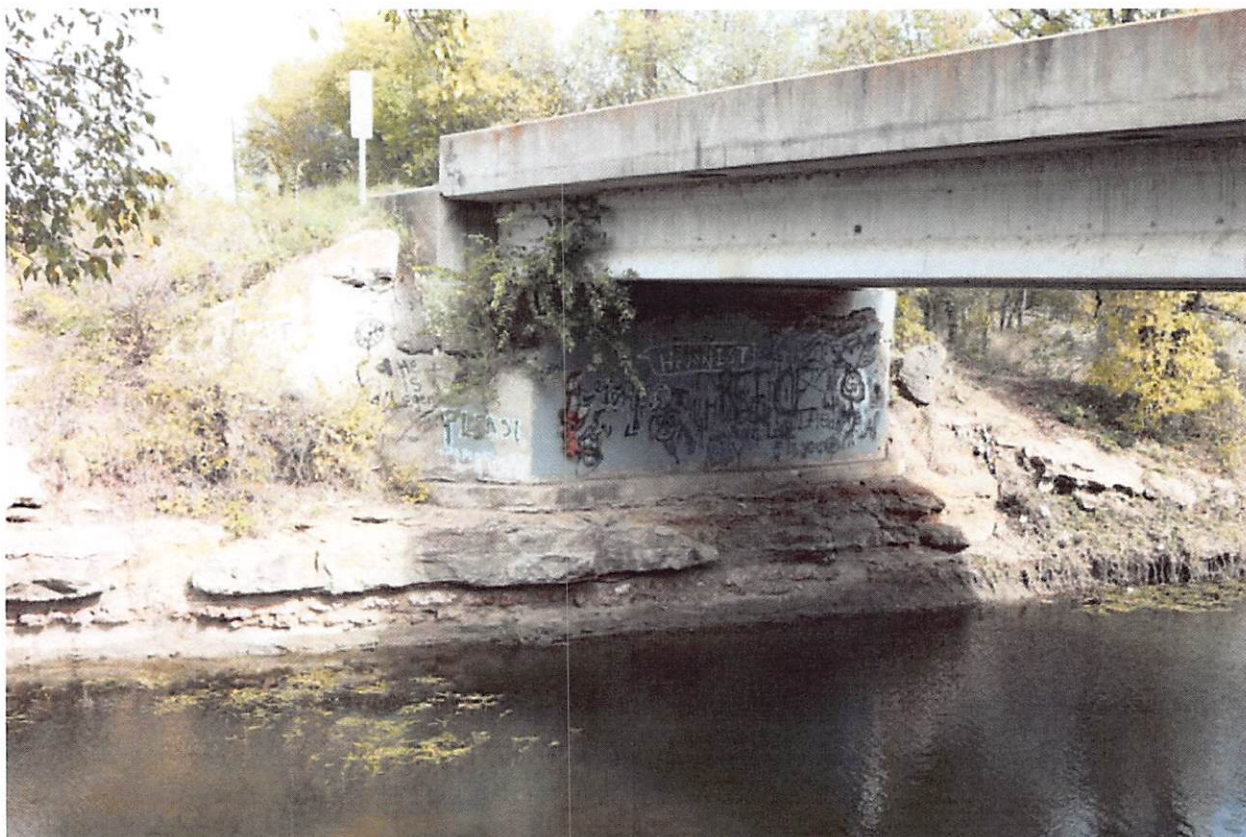
Channel & Approaches: The channel is eroding. Softer layers of rock are eroding out from underneath harder layers above causing large sections of the bank to fall into the stream. It is not apparent if support for the original abutments exists below the rock or if they were cast on top of/into the surface rock. Areas of grouted riprap have also been undermined and are losing support.

Figure 51: Channel Sides Supporting Original Abutments are Eroding

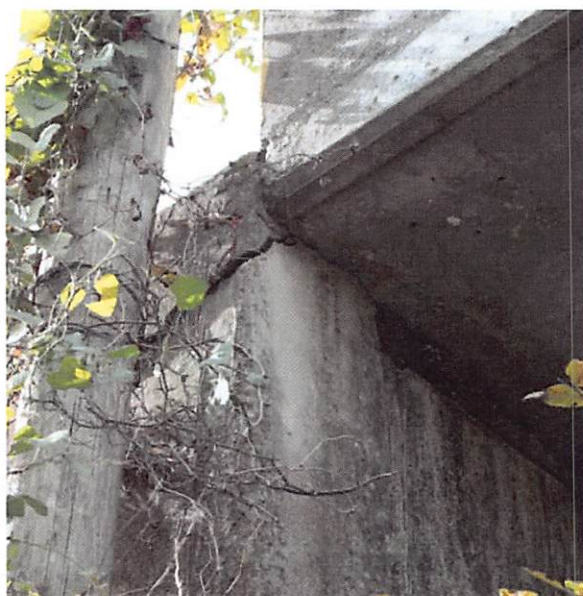
Figure 52: Concrete Abutment Backwall is Cracked

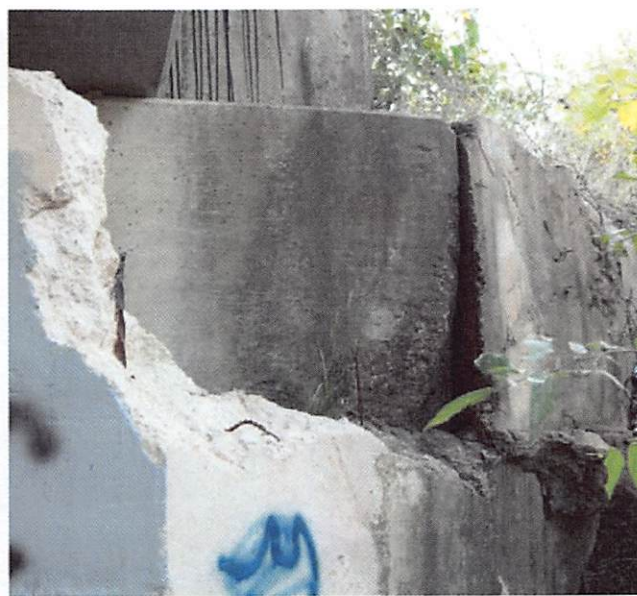
Figure 53: Pier Cap for Current Bridge is Integral with Original Bridge Abutment

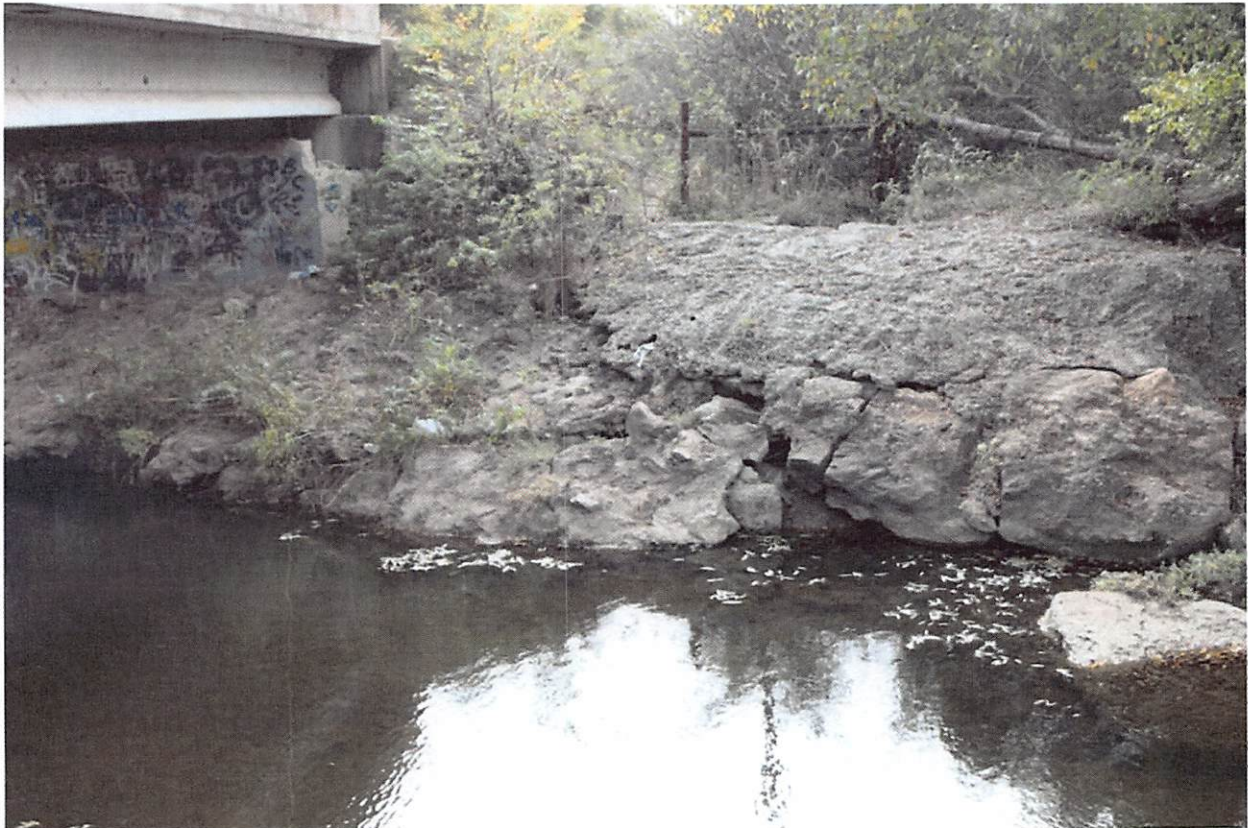
Figure 54: Grouted Riprap is Undermined and Losing Support

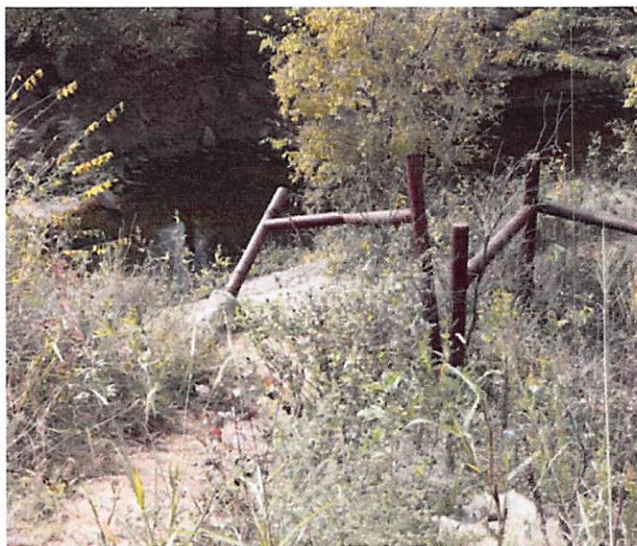
Figure 55: Erosion Down Banks has Caused Fence Posts to Wash Out

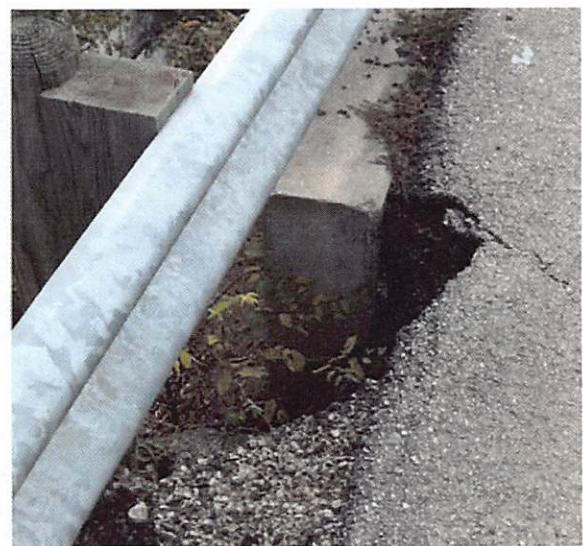
Figure 56: Erosion Near Approach Slab Undermining HMA Pavement
