Roof Asset Management Program

CGP Travel Information Center

Facility: Tourist Information Center

Report Date: 11/19/2015

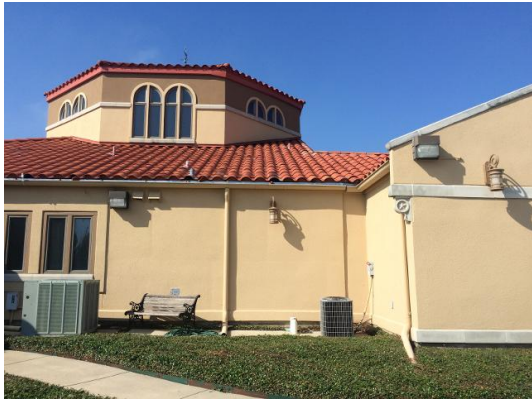
Photo 1

Roofing section with many cracked and broken tiles. Many of these have been repaired the past couple of years and continue to leak on the interior.

1. Remove existing Clay Tile roof and install Waterproofing membrane at eaves and valleys.
2. Install R-Mer Span** structural standing seam roof system.

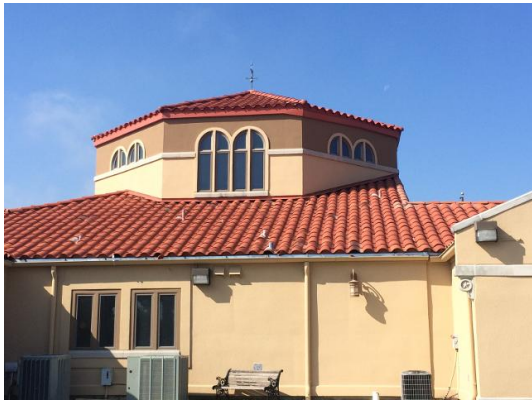
Photo 2

Roofing section with many cracked and broken tiles. Many of these have been repaired the past couple of years and continue to leak on the interior.

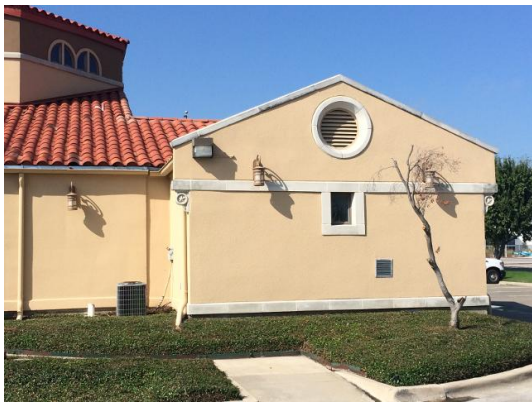
Photo 3

Upper section with many missing tiles.

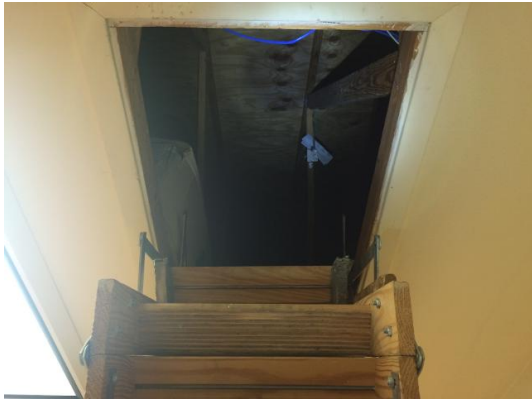
Photo 5

Wood Decking as roofing substrate.
